Manhole Inspection Summary

Manhole # S29QQ1001MH

Insp Date: **2/27/07 1:52 PM**

Location Address: **300 OAKDALE RD**

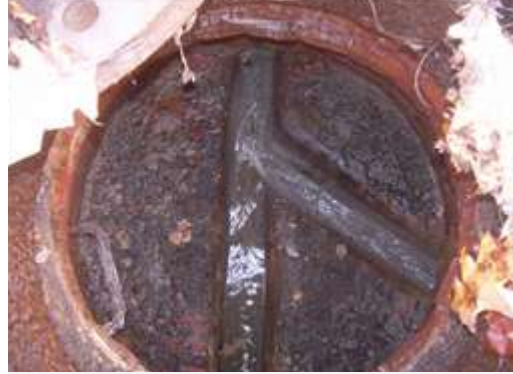
Top View

Corroded steps. Evidence of surcharge - Bench debris.

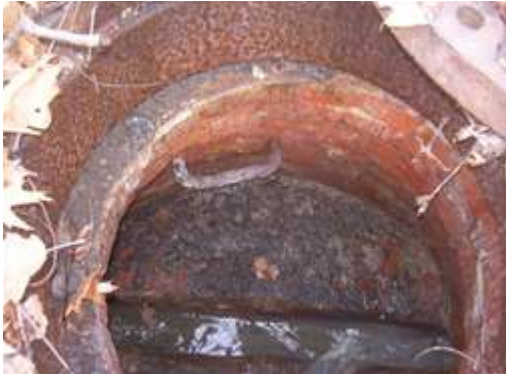
Defect

Frame offset. Adjustment deterioration and infiltration. Corbel and Barrel infiltration.

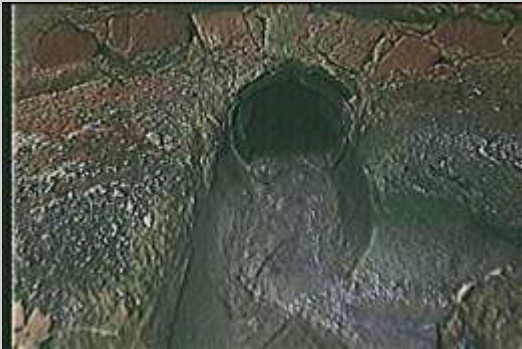
6 in. Circular Gravity Sewer Pipe Out @ 12 O'Clock

Barrel deterioration and infiltration.

Infiltration: **Evidence** Pipe Seal Cond: **Cracked**

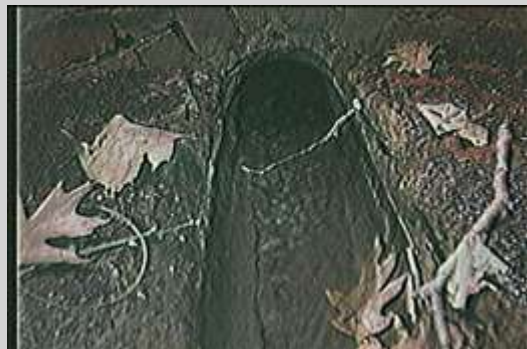
Pipe In @ 6 O'Clock

Channel cracks.

Infiltration: **Evidence**

Pipe Seal Cond: **Cracked**
